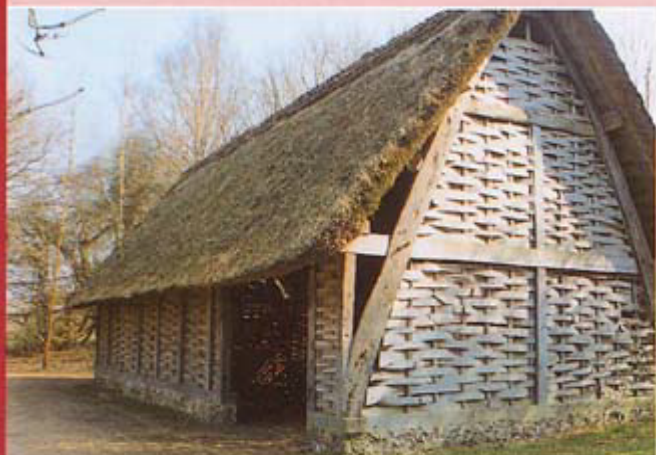
BELOW: The barn at Carter's Hill Farm at Arborfield near Reading in Berkshire. It was offered to the Museum in 1977 when it was condemned as unsafe.
