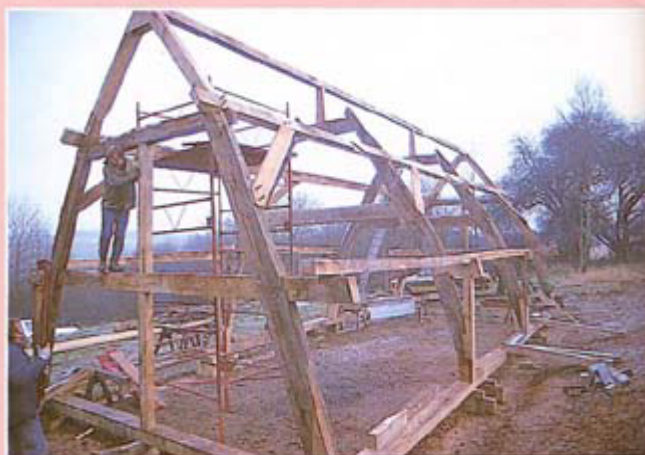
LEFT: The split oak for the walls was prepared by Mr Cottrell of Harpsden, Henley, Oxfordshire and was woven in the wall panels by volunteers. The thatching was done by Harwood and Holden.
